# **Discovery and rectification of an error in high resistance traceability at NPL: a case study in how metrology works**

Speaker: Stephen P. Giblin,

National Physical Laboratory, Hampton Road, Teddington, Middx. TW110LW, U.K.

## **Abstract:**

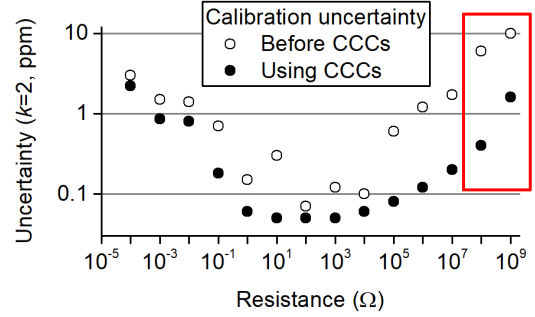
Figure 1. Relative expanded ( $k=2$ ) uncertainty in parts per million as a function of resistance value, for d.c. resistance calibrations at NPL. Open circles: pre-CCC uncertainties. Filled circles: after adoption of CCCs. All uncertainties are published on the calibration and measurement capability (CMC) database.

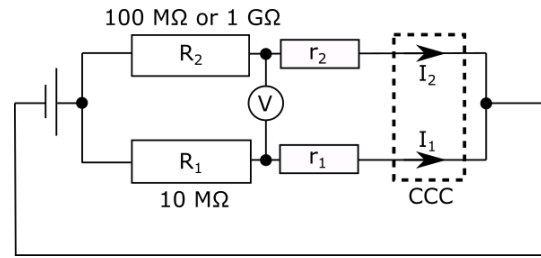
are measured against a 10 M $\Omega$  standard, with the bridge configured for a 1:10 (for a 100 M $\Omega$  calibration) or 1:100 (for a 1 G $\Omega$  calibration) ratio. The current from a single voltage source divides in the two arms of the bridge, and the superconducting comparator measures the ratio of the two currents  $I_1/I_2$ . In figure 2,  $R_1$  is the 10 M $\Omega$  reference resistor and  $R_2$  is the unknown resistor of either 100 M $\Omega$  or 1 G $\Omega$  nominal value. Both  $R_1$  and  $R_2$  are two-terminal standards, meaning they have just two wires connecting the resistance element to the measuring circuit. The complication is that the standard resistors are in series with parasitic circuit resistances  $r_1$  and  $r_2$ , consisting of connecting leads and wiring, and the CCC current ratio  $I_1/I_2$  only contains information about the total resistance in the bridge arms:  $I_2/I_1 = (R_1+r_1)/(R_2+r_2)$ .

Figure 2. Simplified circuit diagram of the CCC bridge used to measure a 100 M $\Omega$  or 1 G $\Omega$  standard  $R_2$  in terms of a known 10 M $\Omega$  standard  $R_1$ . The additional series resistances due to connecting leads and other wiring are denoted  $r_1$  and  $r_2$ .

To extract the ratio of the standard resistors  $R_2/R_1$ , the bridge circuit includes a voltmeter. The voltmeter signal combined with the CCC current ratio yields the required ratio of the standard resistors while eliminating the effect of the parasitic resistances [7]. The error arose because the voltmeter data was not used correctly at the data analysis stage to compute the value of  $R_2$  from the raw bridge data. To a good approximation, the calculated value of  $R_2$  was too low by a relative amount  $r_1/R_1$ . The error was specific to the resistance values 100 M $\Omega$  and 1 G $\Omega$ . For the lower values of resistance measured on this bridge, servo control of the CCC current ratio was used resulting in a different bridge equation, and in this case the analysis software was correct. Fortunately, the voltmeter signal was saved in all raw calibration data files, and the data files were saved and archived without any processing. This allowed the data files to be re-analysed, and correct values of  $R_2$  to be calculated after the error was discovered.

The parasitic resistances  $r_1$  and  $r_2$  include the leads connecting the standard resistors to the CCC electronics and the electronics to the superconducting comparator. They also include wires and relay contacts internal to the electronics. The presence of relay contacts is important to the specifics of our problem, because relays may not have the same resistance every time they are opened and closed again. The value of  $r_1$  was usually in the range 5  $\Omega$  to 10  $\Omega$ , yielding a relative error in the value of  $R_2$  between 0.5 parts per million (ppm) and 1 ppm. This can be compared to the expanded ( $k=2$ ) uncertainties already stated, of 0.4 ppm for 100 M $\Omega$  and 1.6 ppm for 1 G $\Omega$ . Clearly, for the case of 100 M $\Omega$  the error was larger than the claimed uncertainty.

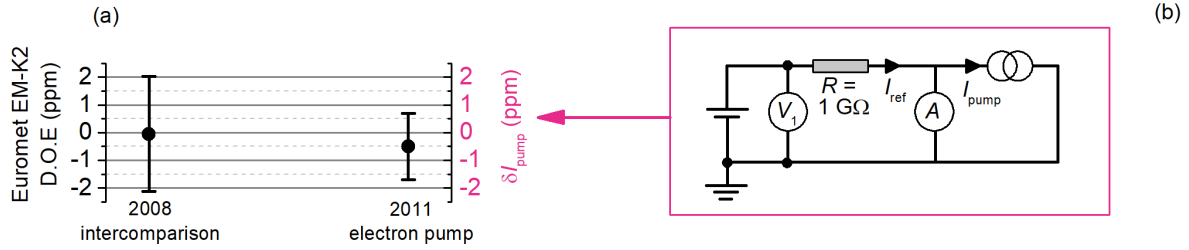
Figure 3. (a): Two data points which did *not* lead to discovery of the CCC error. Error bars are standard ( $k=1$ ) uncertainties. The left data point (left axis) is the degree of equivalence for NPL's participation in the Euromet EM-K2 comparison of 1 G $\Omega$  resistance standards [8]. The right point (right axis) is the electron pump current measured using the circuit in (b) and reported in Ref. [10]. (b): Simplified circuit diagram showing the measurement of an electron pump current  $I_{\text{pump}}$  in terms of a reference current  $I_{\text{ref}}$ .

The left data point in Fig. 3(a) shows the NPL degree of equivalence (DOE) result for the comparison at 1 G $\Omega$ , with the error bar showing the standard ( $k=1$ ) uncertainty. Statistical analysis of inter-comparisons is a complex and evolving subject, but the DOE is an accepted indicator of how well a laboratory's result agrees with the other laboratories. The uncertainty in the DOE reflects the uncertainty NPL reported for its measurement of the comparison standard, but also the uncertainty of the other laboratories as well as additional uncertainty associated with the drift of the transport standards during the timeframe of the comparison. Clearly NPL's DOE does not indicate any discrepancy within the expanded  $k=2$  uncertainty of 4 ppm.

The first measurement campaign using this system was published in 2012 [10], demonstrating that the normalised difference of the electron pump current from  $ef$ , with standard ( $k=1$ ) uncertainty, was  $(-0.51 \pm 1.2)$  ppm. This data point is plotted as the right-hand point in Fig. 3(a). This was a breakthrough result, the first experimental demonstration of ppm-accuracy in an electron pump, for a continuously generated current. Higher accuracy had been demonstrated by a team at NIST many years previously, for much lower currents, in cyclic

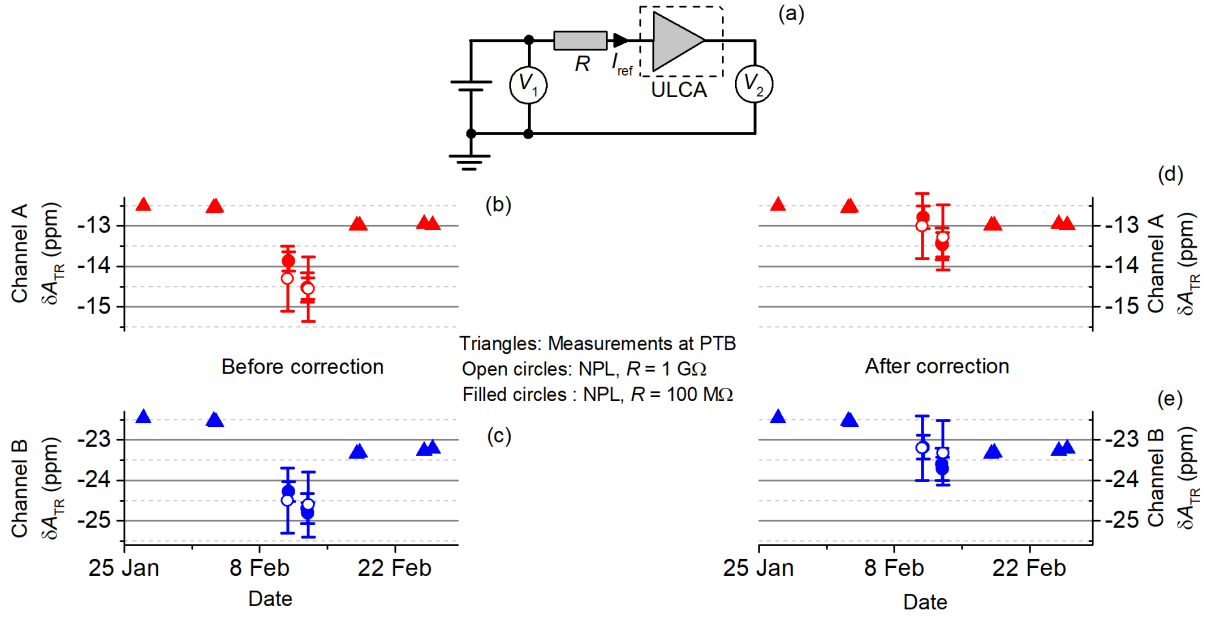
Figure 4. (a): Simplified circuit diagram showing the calibration of the ULCA current-to-voltage gain at NPL, reported in Ref. [17]. (b) and (c): values of the ULCA gain measured at PTB (triangles) and NPL (circles) in early 2015. The NPL data is shown as first analysed, including the error in the resistance traceability. The error bars show the standard ( $k=1$ ) uncertainty and are roughly the same size as the data points for the PTB data. The data is expressed as the deviation of the gain in parts per million from its nominal value of  $1 \text{ G}\Omega$ . (d) and (e): the same data after correcting the error in the NPL resistance traceability. This is a subset of the data that appears as the bottom panel of figure 5 in Ref. [17]

NPL first calibrated the gain of a 2-channel ULCA (essentially two separate ULCA's in one box) in early February 2015. For these calibrations, the same reference current source from the single-electron research programme was used to feed a current into the ULCA input. Referring to the circuit diagram in figure 4 (a),  $I_{\text{ref}} = V_1 / R$ , and  $A_{\text{TR}} = V_2 / I_{\text{ref}}$ , so  $A_{\text{TR}} = RV_2 / V_1$ . The voltmeters measuring  $V_1$  and  $V_2$  were calibrated frequently against a primary standard with uncertainties of a few parts in  $10^7$ . Both 100 M $\Omega$  and 1 G $\Omega$  resistors were used for  $R$ .

The  $A_{\text{TR}}$  results calculated at the time of the NPL measurements for the two ULCA channels are shown in figures 4 (b) and (c). The markedly lower uncertainty for the PTB calibrations was possible by calibrating the ULCA gain in a 2-stage process directly using a CCC [16], a technique which was only developed at NPL several years later. After the ULCA had been returned to PTB and calibrated a few times there, it was clear that the NPL measurements were about 1.5 ppm below the PTB measurements for both ULCA channels (the two channels are electrically independent, but mechanically share the same case). This was one of the first ULCA transportation tests, and the transport stability of the ULCA was not at all well established at this time. Nevertheless, it seemed implausible that *both* channels should experience the same jump *down* in gain on the first transport to NPL, and then a jump back *up* on the second transport back to PTB. An error in the NPL reference current was the simplest explanation for the data, and it would have to be an error which affected both 100 M $\Omega$  and 1 G $\Omega$  resistors by an almost equal amount. This data was the smoking gun that triggered an investigation of the CCC bridge, and the error was found within a few days of starting the investigation. The ULCA calibration data was re-analysed using the corrected values of the 1 G $\Omega$  and 100 M $\Omega$  resistors (figure 4 (d) and (e)), and subsequently published along with data from LNE (France) with the conclusion that the ULCA gain was robust at the 1 ppm level during international transportation [17]. A few years later, another NPL – PTB study on ULCA transportation improved this number to 0.2 ppm [18], and other studies on the ULCA have shown it to have sub-ppm stability on annual time-scales and under a range of transportation conditions [19].

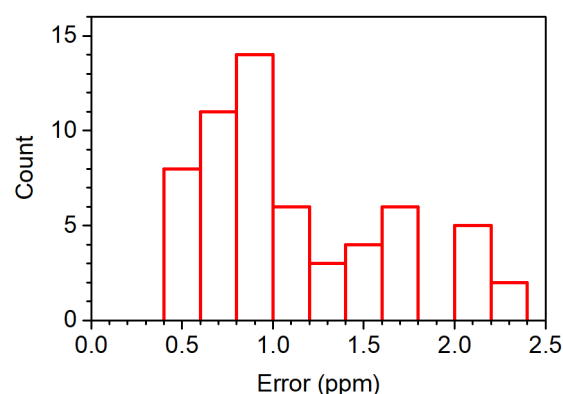
Figure 5. Histogram of the error in 100 M $\Omega$  and 1 G $\Omega$  resistor calibrations (at a test voltage of 100 V) reported to customers.

customers including 3 NMIs. Letters were sent to all the customers with details of the affected calibration certificates, and the size of the error. Figure 5 shows a histogram of the errors reported to customers for resistors calibrated at the usual test voltage of 100 V (calibrations at lower test voltages are not included in this data). The distribution of errors reflects the distribution of relay contact resistances in the circuit path. Most of the errors clustered around the 1 ppm level, with a small number between 2 ppm and 2.5 ppm.
